Assembly instructions

MAPCO 19199 - Gear Lever Sealing Kit

Renault gear box types JB and JC

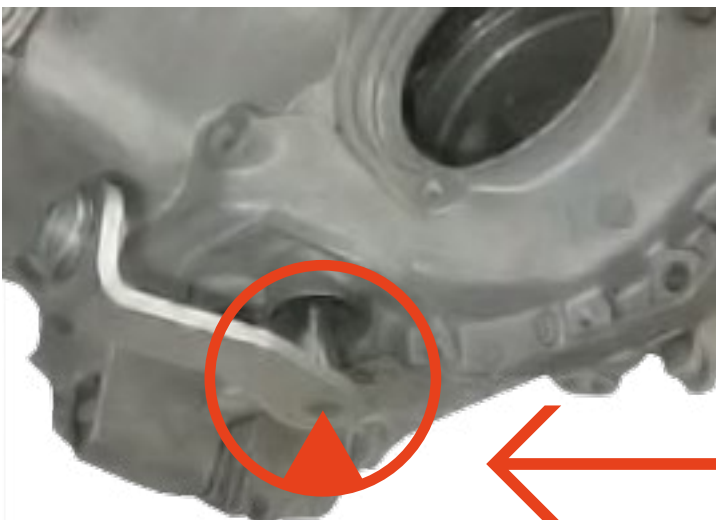
MAPCO Art.-Nr.: 19199

For repairing leaks occurring with gearbox types JB and JC, for Renault cars.
The repair using repair kit 19199 is based on a patented method.

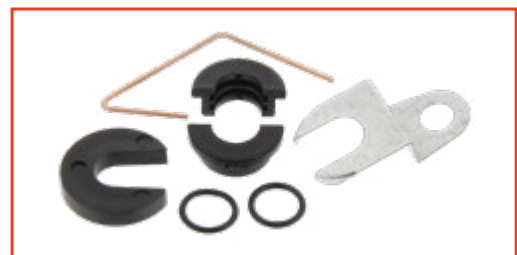
1. All work must be carried out in neutral gear!
2. Remove the existing protection.
3. Destroy the existing seal using diagonal cutting pliers (side cutter).
4. Release clamp, take out gear shift lever.
5. Thoroughly clean the lever!
6.

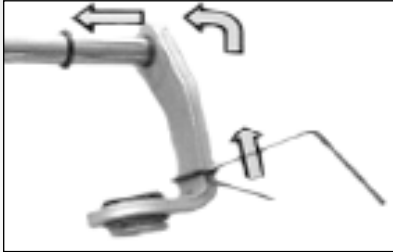
According to the sketch, push on the 2 O-rings, contained in repair kit, onto the lever using the help of the wire (also contained in kit).
7.
